**ANIMAL VEHICLE CRASH
MITIGATION USING
ADVANCED TECHNOLOGY
PHASE I: REVIEW, DESIGN AND
IMPLEMENTATION**

Final Report

SPR-3(076)

1. Report No. FHWA-OR-TPF-07-01		2. Government Accession No.		3. Recipient's Catalog No.	
4. Title and Subtitle Animal Vehicle Crash Mitigation Using Advanced Technology Phase I: Review, Design and Implementation				5. Report Date August 2006

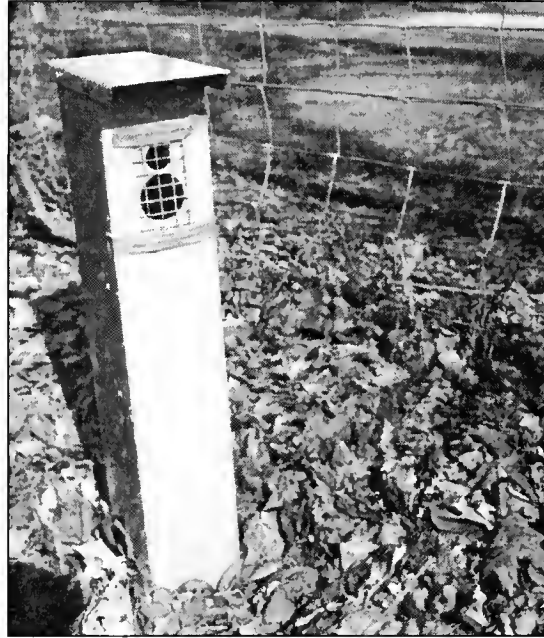
Figure 4.10: Cabinet with infrared sensor in Ugchelen, The Netherlands.
The wire in front of the two openings prevents birds from nesting in the box. (Photo: Marcel Huijser/WTI-MSU).

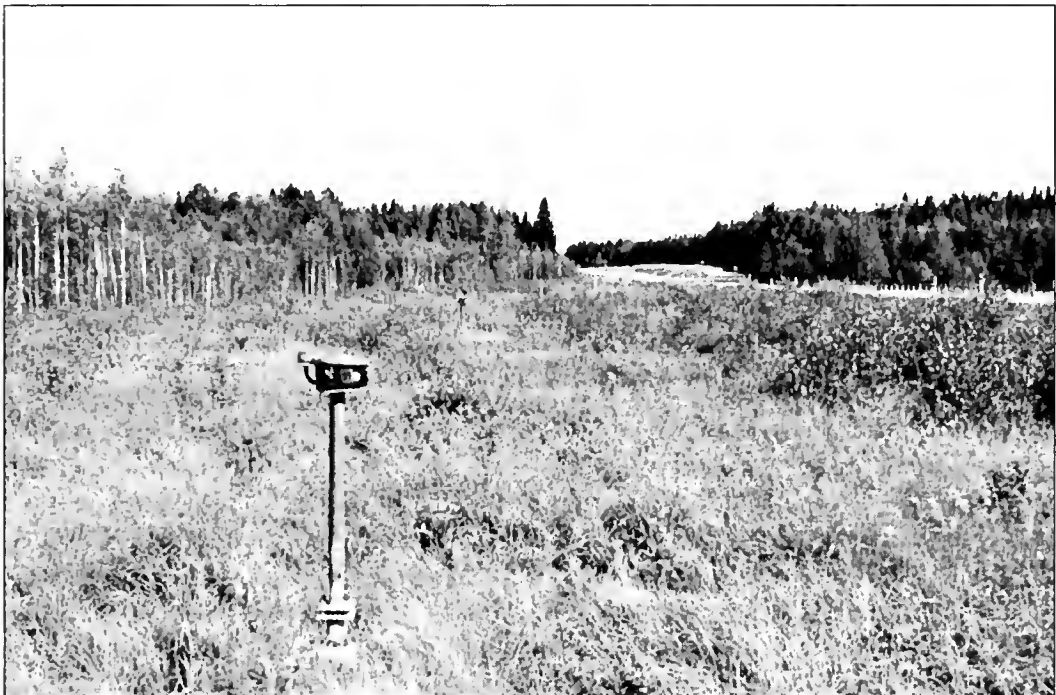
Figure 4.12: The posts holding the lights in Rosvik, Sweden (Photo: Andreas Seiler).

In 1999 an animal detection system was installed along highway E4 near Rosvik in northern Sweden, between Piteå and Luleå (Figures 4.11-4.13) (Andreas Seiler, Grimsö Wildlife Research Station, Department of Conservation Biology, Swedish University of Agricultural Sciences, personal communication; Kjell Ståhl, Road Administration, Luleå, personal communication). The system was designed by PIK AB, Karlskrona, Sweden, and installed by the manufacturer and the Road Administration. The system operates on a break-the-beam principle with infrared light.

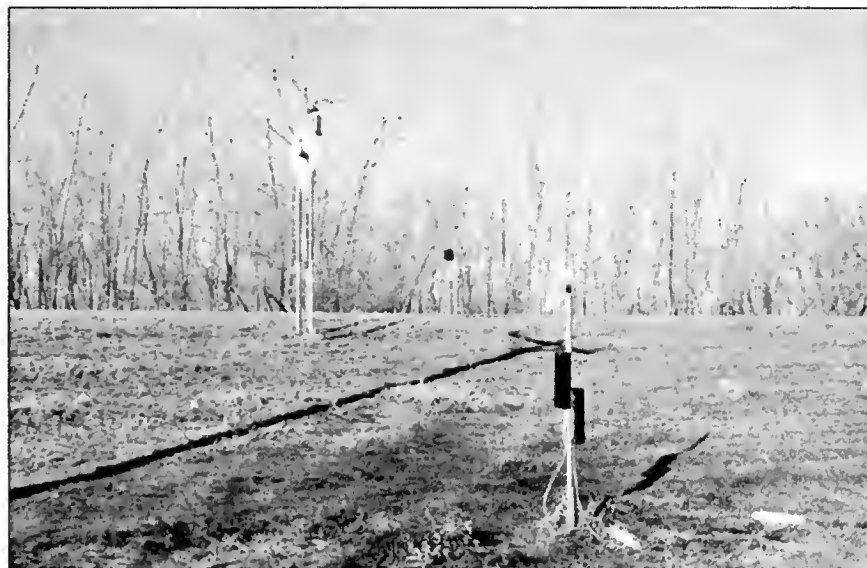
Figure 4.27: The sensors in the right-of-way in Marshall, Minnesota, USA (Photo: Robert Weinholzer, MNDOT)

both beams were broken at the same time. This reduced false detections as a result of e.g., flying birds, but not as a result of heavy fog. When both laser beams in the same segment were broken amber flashing beacons were activated that continued to flash for about one minute. The warning lights were situated on standard deer warning signs (Figure 4.26). In addition, there were advisory signs that notified drivers that they were entering a test area and that deer or other animals may be present when lights are flashing.

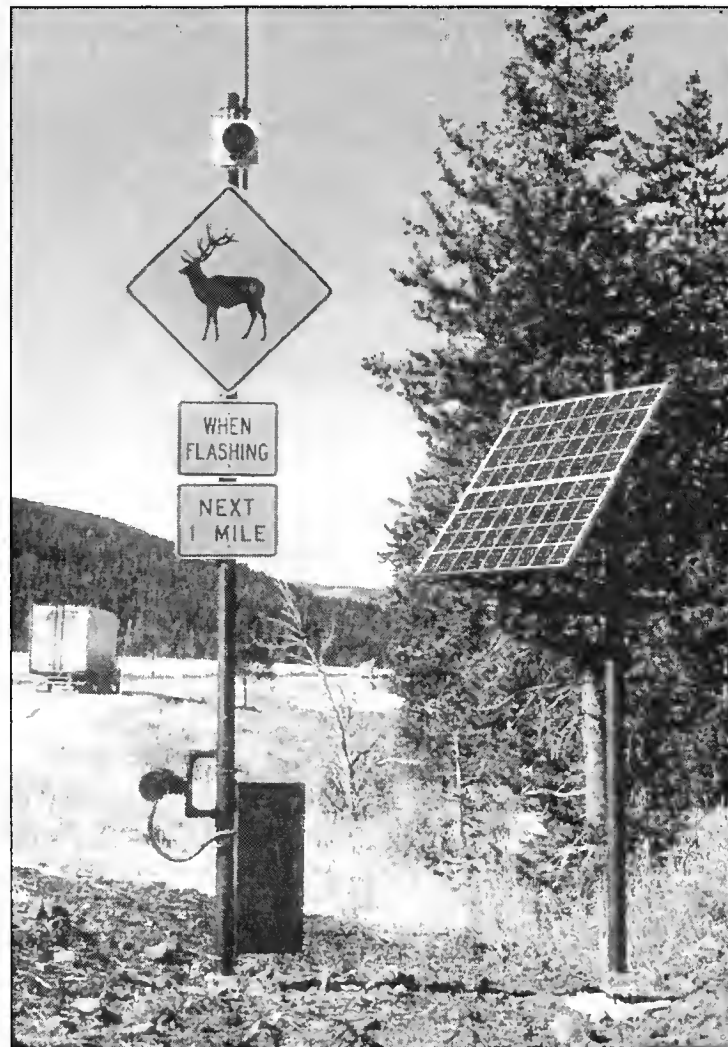
Figure 4.36: Original warning signal and sign in Yellowstone National Park, Montana, USA. A sensor is attached on the left side of the post; a cabinet with circuit boards and batteries is attached to the right side of the post. (Photo: Marcel Huijser, WTI-MSU)

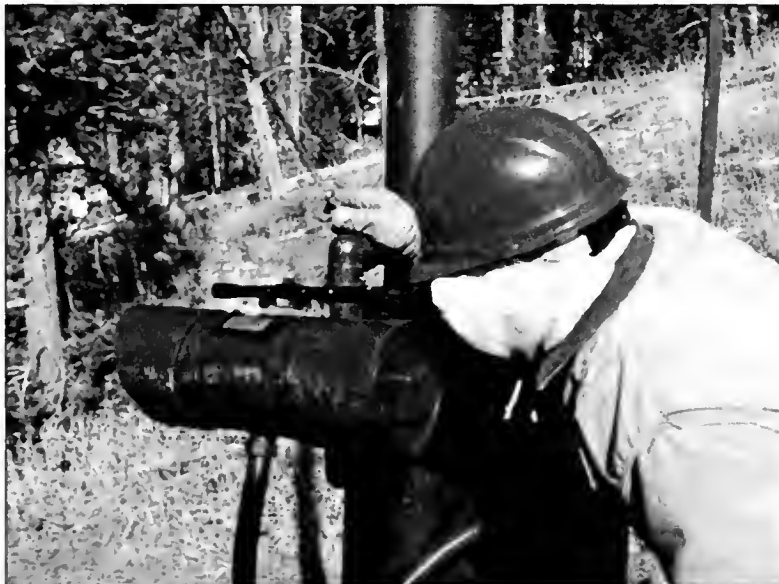
Figure 5.24: Sensors at the MT site were aligned by using a scope (Photo: Marcel Huijser, WTI-MSU)

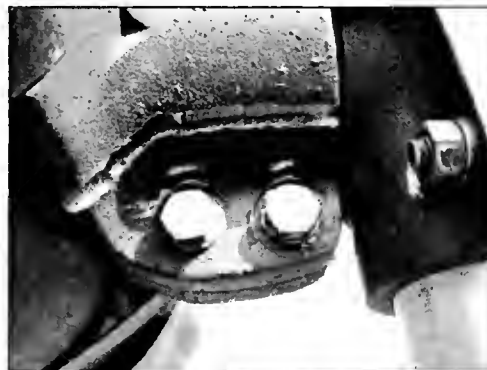
Figure 6.8: The brackets holding the sensors cracked as a result of extreme temperature fluctuations at the MT site
(Photo: Marcel Huijser, WTI-MSU)

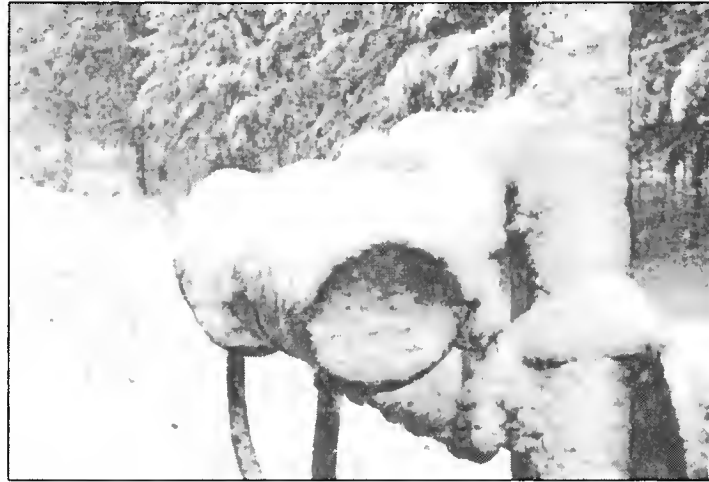
Figure 6.9: Snow and ice build-up on the sensors caused false positives at the MT site (Photo: Marcel Huijser, WTI-MSU)

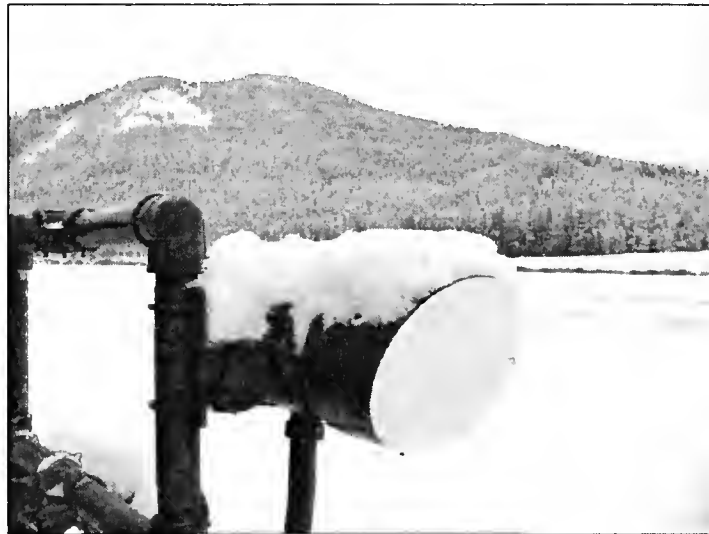
Figure 6.10: Placing a smooth surface at an angle in front of the sensors prevented snow and ice build-up on the sensors at the MT site (Photo: Marcel Huijser, WTI-MSU)

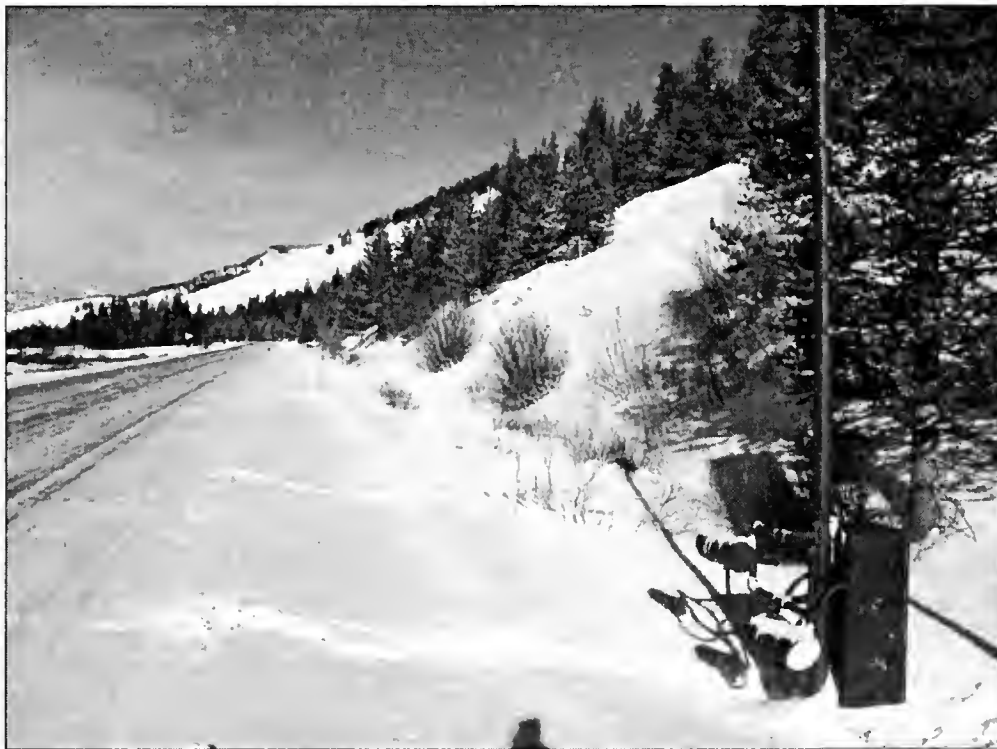
Figure 7.6: Investigation for potential blind spots. The tracks indicate where human models passed through the beam. (Photo: Marcel Huijser, WTI-MSU)

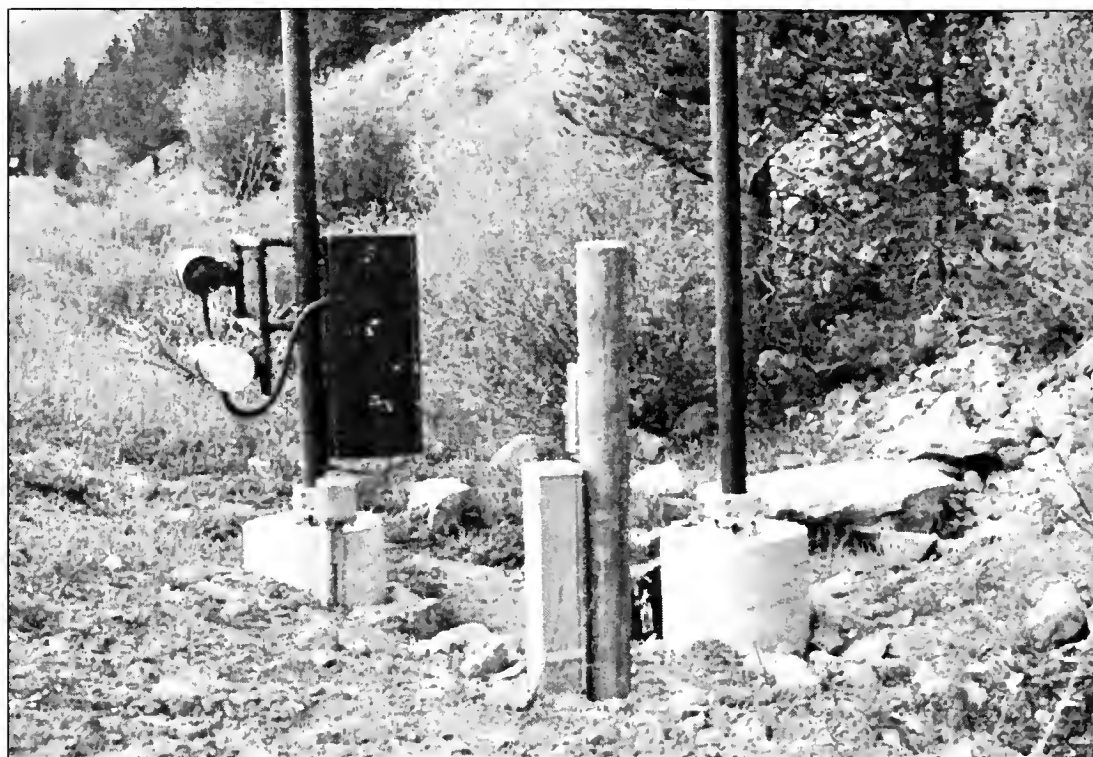
Figure 8.1: Some of the concrete foundations were in the clear zone and too high above the ground. This is the master station. The wooden post on the foreground is for the link to the land-based phone line. (Photo: Marcel Huijser, WTI-MSU)

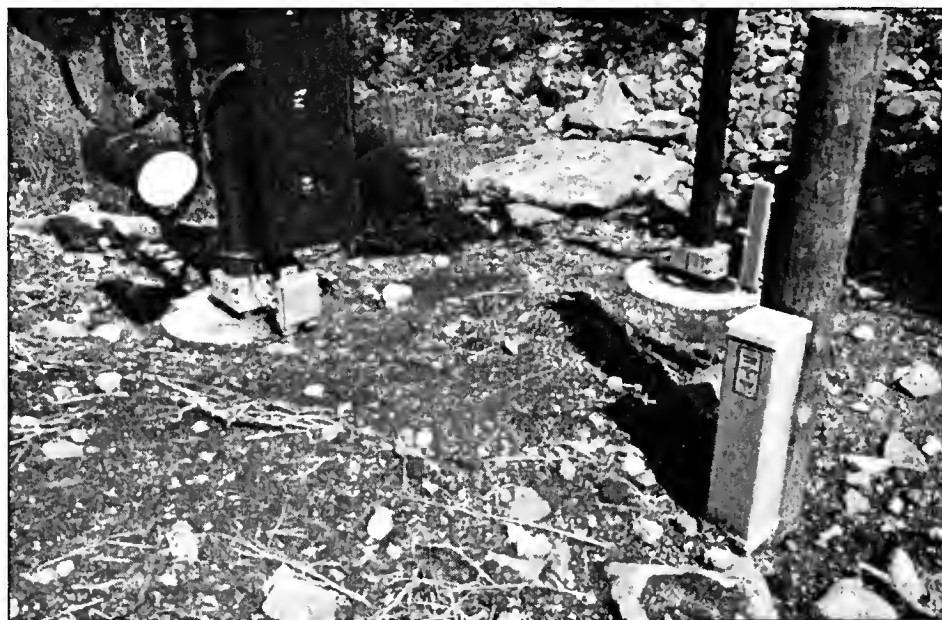
Figure 8.2: The problem with some of the concrete foundations was addressed by putting weed free soil around the posts while not blocking the drainage from the road. (Photo: Marcel Huijser, WTI-MSU)

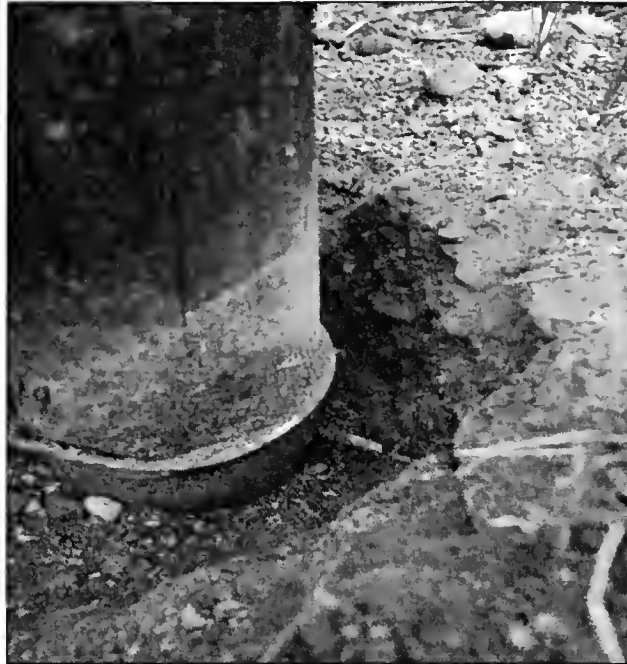
Figure 8.3: Some of the wooden poles were buried too deep. The stick indicates the upper of the three holes that serve as a break-away in case of a collision. All three holes should have been above the ground level. (Photo: Marcel Huijser, WTI-MSU)

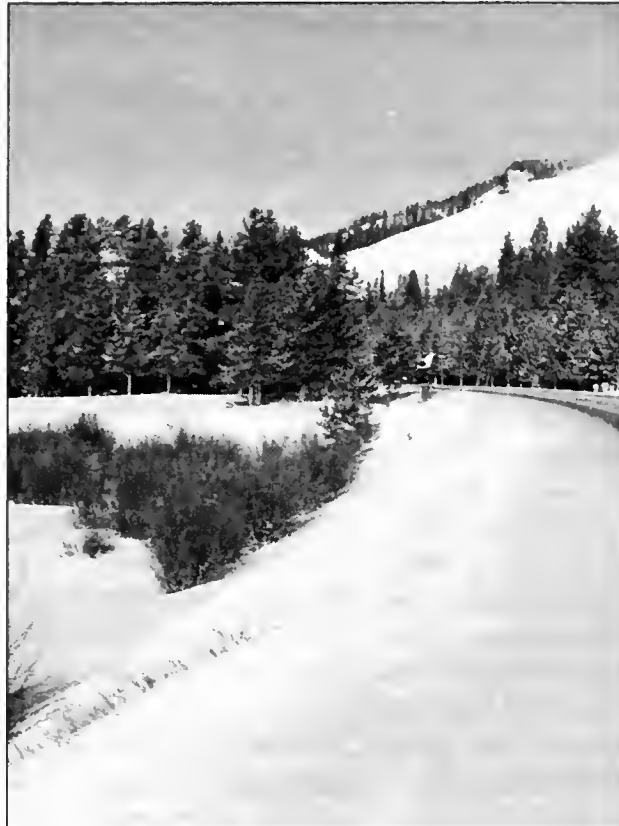
Figure 8.5: Curves and slopes caused the beam to shoot too high in some locations at the MT site, causing blind spots. Shown here is detection Zone 8 (see Figure 5.7 for exact location). (Photo: Marcel Huijser, WTI-MSU)

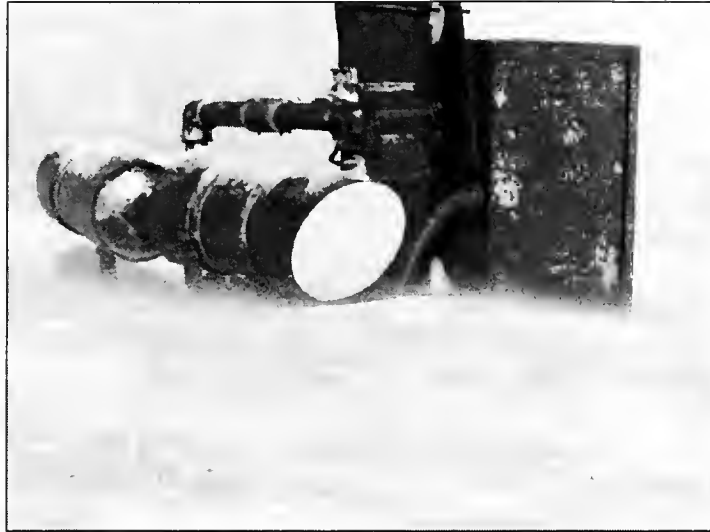
Figure 8.6: Snow accumulation at the MT site. Snow accumulation may bury the sensors, potentially causing downtime for the system. (Photo: Marcel Huijser, WTI-MSU)

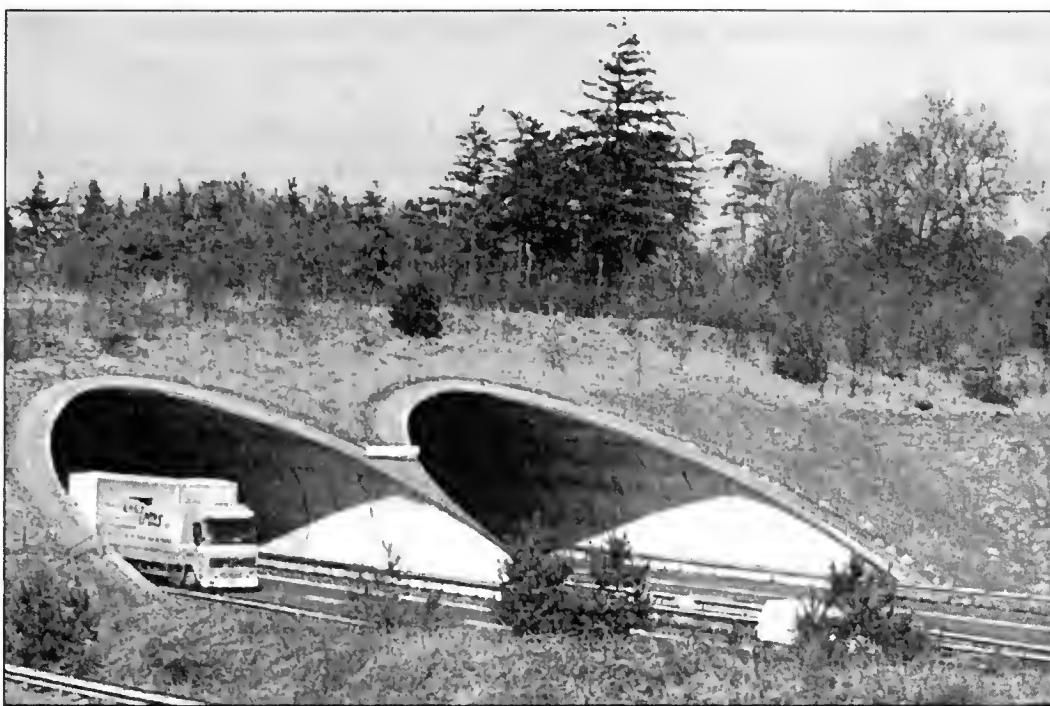
Figure 10.2: Wildlife crossing structures are often combined with wildlife fencing to guide the animals towards the crossing structure. Since some animals may walk the other way and cross the road where the fence ends, an animal detection system may be applied also. (Photo: Marcel Huijser, WTI-MSU)

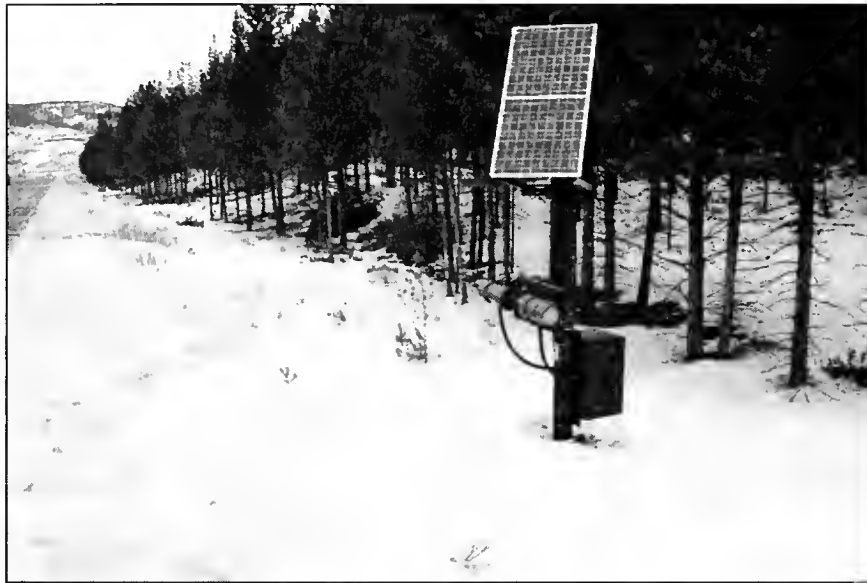
Figure 10.3: Animal detections may reduce or prevent animal-vehicle collisions, but the poles and equipment in the right-of-way form a hazard of their own. Here a car went off the road at the MT site and just missed the pole. However, the damage to one of the sensors was about \$2000. (Photo: Jason Norman, MDT)
